**HURRICANE KATRINA:
WHY DID THE LEVEES FAIL?**

**COMMITTEE ON
HOMELAND SECURITY AND
GOVERNMENTAL AFFAIRS
UNITED STATES SENATE**

NOVEMBER 2, 2005

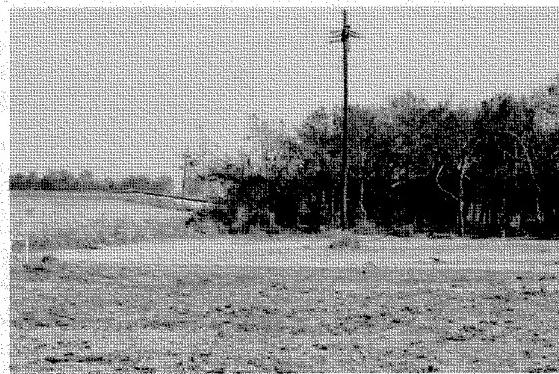
Residences in Pointe a la Hache were commonly inundated to depths of 12 to 15 feet (see Figure 5.6). Flooding was so great that water flowed across the community from the east

Figure 5.6: Photograph of flood elevation on trees landward of hurricane levee east of Pointe a la Hache – illustrating that flood water remained to large depths for extended periods (October 12, 2005)

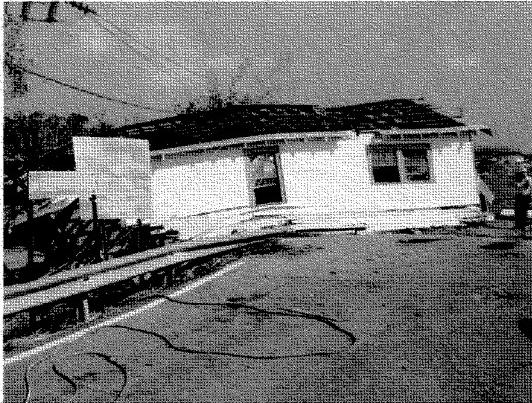
Like many New Orleans residences, the small wooden homes in Pointe a la Hache were commonly founded on cinderblock piers. As a result of the deep flooding and the flow towards the Mississippi River, homes in Pointe a la Hache were commonly picked up and floated away from their foundations. Many ended up being deposited on or across the Mississippi River Levee as a result of flood waters flowing into the Mississippi River (see Figures 5.7 through 5.9).

Figure 5.7: Photograph of Pointe a la Hache home deposited on Mississippi River levee crown after storm surges overtopped this levee from the east (left) towards the river – which is to the right in this photograph (October 12, 2005)

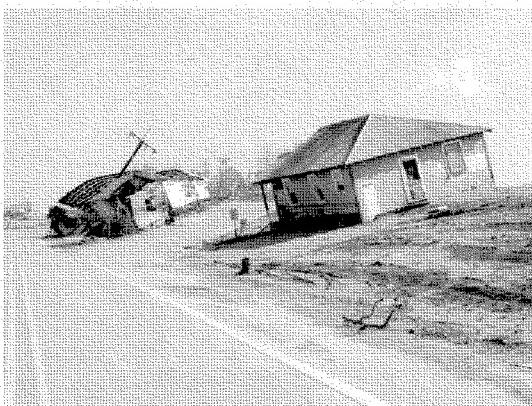
Figure 5.8: Photograph of Pointe a la Hache homes deposited on Mississippi River levee after storm surges overtopped the levee from the east (left) towards the river (right) (October 12, 2005)

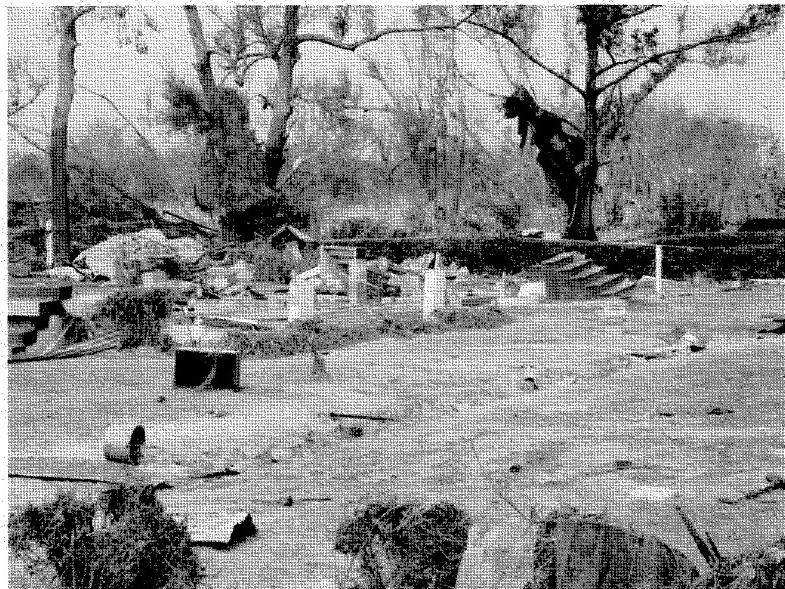
Figure 5.9: Photograph of Pointe a la Hache home site where wooden home was floated off of its cinderblock piers – note concrete stairs and black plastic sheet in tree illustrating the depth of flooding (October 12, 2005)

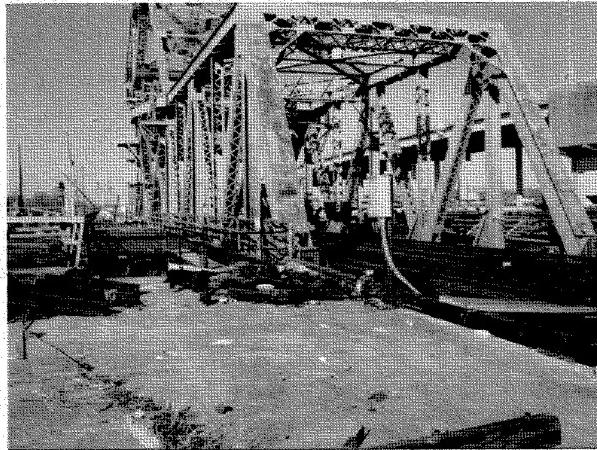
An example of system vulnerabilities associated with the multiplicity of organizations was found on the east side of the IHNC at the lake front adjacent to the railroad bridge that crosses this canal near the Lakefront Airport (Figure 6.1). Inspections of this area clearly indicated that large amounts of water had entered through a railway opening in the adjacent concrete flood wall and soil levee (Figure 6.2). The inspection did not disclose the presence of a flood gate that had closed the railway opening, even though immediately adjacent to this opening was a securely closed flood gate and concrete flood control structure maintained by the USACE (this gate and the adjacent flood control structure had not been breached and showed no signs of overtopping). The low spot in this complex interchange was the base of the railroad ballast, and it was here that the water had flowed through. Attempts had been made to place sandbags prior to the arrival of hurricane Katrina; the attempts had not been successful and water had poured through the opening flooding the areas immediately south and west of the opening.

Figure 6.1: A railroad bridge adjacent to the Lake Pontchartrain frontage road.

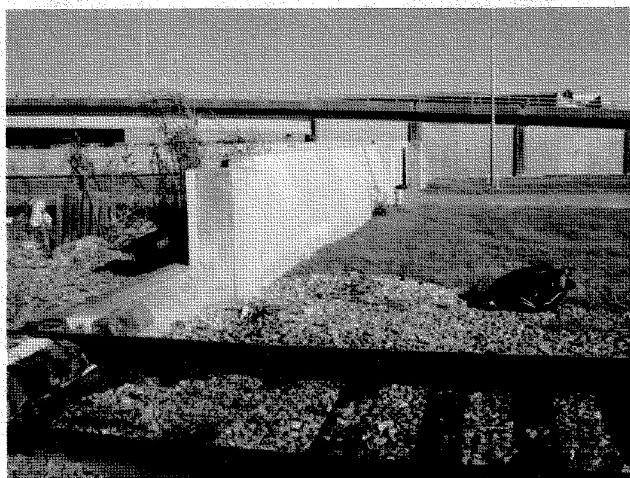
Figure 6.2: Lack of a floodgate at the railroad line crossing resulted in scour around the railroad tracks. No overtopping was observed the floodgate across the adjacent roadway.

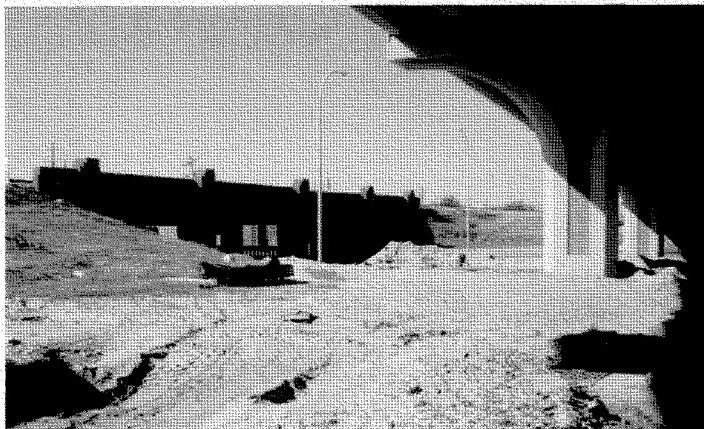
Another example of system vulnerabilities associated with the multiplicity of organizations occurred in the same area, near the lake front airport (Figure 6.3). The earth levee that paralleled the lake front defending the neighborhood to the south of the Lakefront airport had experienced some overtopping, but water had breached a section between the adjacent flood control structure (concrete, flood gate closed) and the earth levee (Figure 6.4). The earth levee was at an elevation that was lower than the flood control structure. Massive

Figure 6.3: Lack of a flood gate beneath the railroad over-crossing facilitated the flooding of residential neighborhoods.

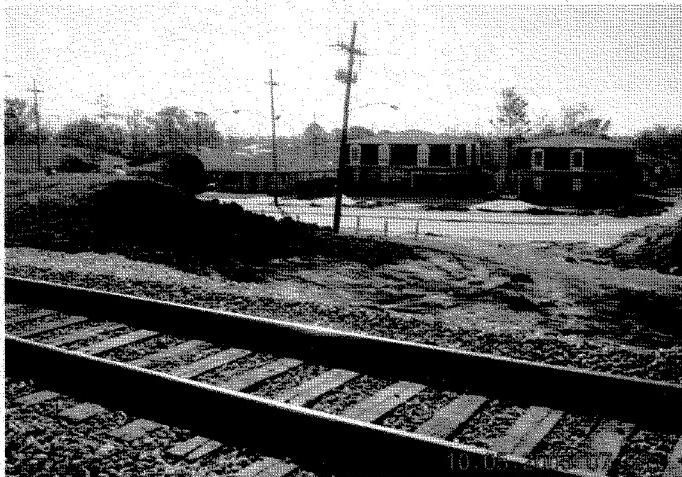
Figure 6.4: This flood protection levee was overtopped and scoured, resulting in flooding of this lakefront residential area.

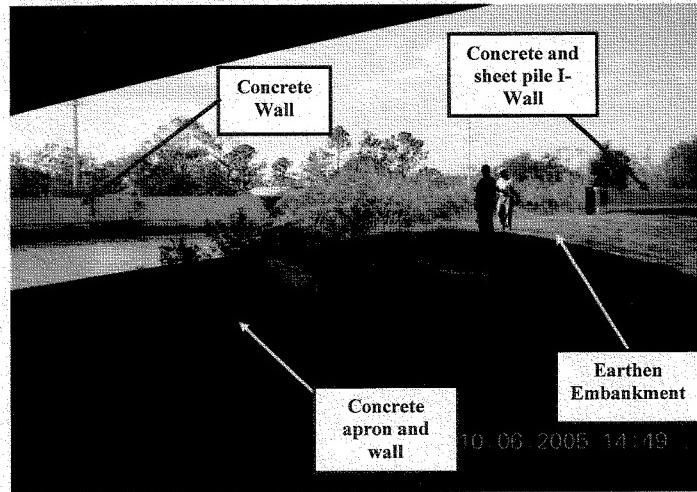
After touring the pump station, we surveyed the area immediately outside of the pump station to determine how the flood walls and other parts of the levee system had performed. We found that it had performed very well, with little signs of overtopping. However, as we toured the area we found that there were 5 different elevations of different parts of the levee system in a small area (Figure 6.8). A significant example of this occurs on the east bank where the floodwall on the earthen levee abruptly ends at a considerable distance (some 300 feet) before the levee reaches the pumping station, leaving a long, low gap where there should have been a contiguous, closed perimeter flood defense. A similar situation occurs on the west side where the floodwall transitions into a short stretch of sheet pile with a considerably lower elevation. Note that these gaps provide access of floodwater into the surrounding residential areas at a water level well below the flood protection system design level. Some overtopping had in fact occurred in both places, as reported by the pump station operator, who was onsite during Hurricane Katrina. Other variations in the elevations of the flood defense elements were correlated with the agencies that had responsibilities for various parts of this part of the system, (e.g. highway department determining the heights under the road overpass immediately adjacent and upstream of the pump station, Figure 6.9)).

Figure 6.9: At the Orleans Canal pump station, the flood protection system consisted of different components, each with a different "top of wall" elevation.

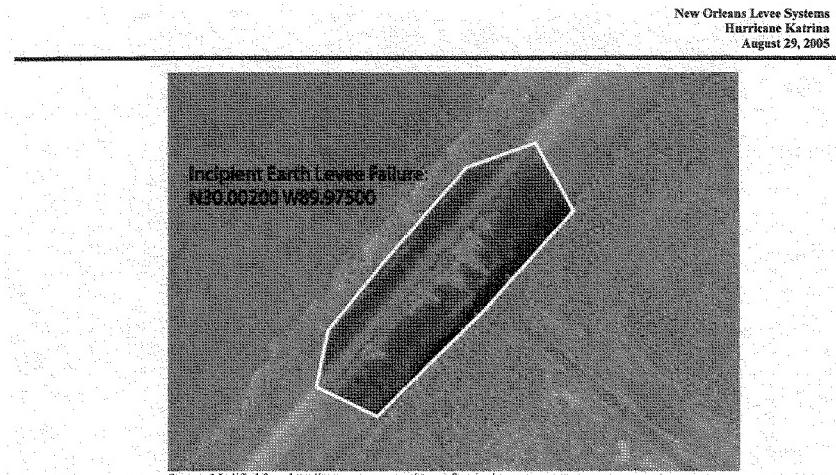
Figure 7.11. Incipient Earth Levee Failure at N30.00200°, W89.97500°

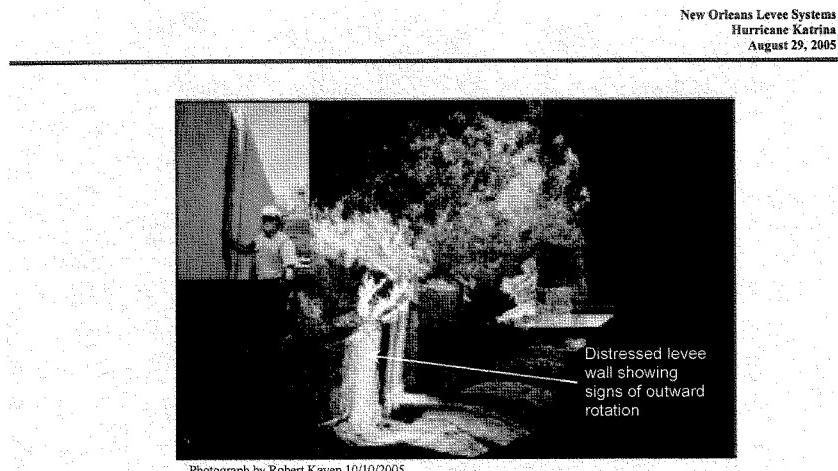
distress and lateral deformation associated with incipient failure of the levee. This movement is along a section of wall diagonally northeast of the west side breach across the canal. In Figure 7.13, an oblique image of the distressed wall can be seen from the south. The wall, preserved in incipient failure, leans toward the levee maintenance road and landside portion of the levee. In the right-hand background, is the bridge abutment on Robert E. Lee Blvd for reference.

Figure 7.13: Leaning I-wall of a distressed portion of the London Avenue Canal. The wall leans toward the levee maintenance road and landside portion of the levee. In the right-most background is the abutment of the bridge on Robert E. Lee Blvd. along with vegetation on the canal side of the levee.

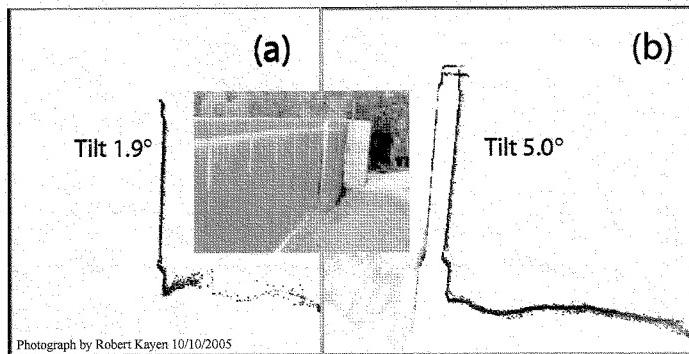
Photograph by Robert Kayen 10/10/2005
Figure 7.14: Cross sections through two segments of distressed I-wall at London Avenue Canal. Segment (a) is toward the south (left) of Figure 7.13 and has a modest 1.9 degree rotational deformation toward the landside of the levee. Near a position of maximum distress, the I-wall has 5.0 degrees of rotational deformation.

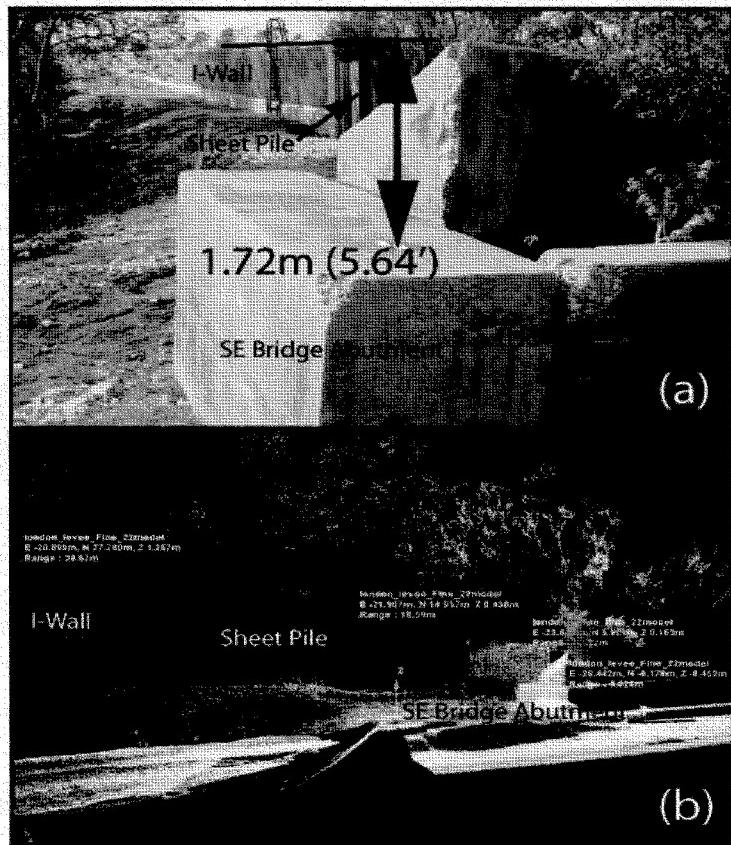
The London Canal levee failure (west side) and distressed wall (east side) are both immediately south of the bridge crossing at Robert E. Lee Boulevard. A significant gap in height between the lower un-walled bridge abutment and I-wall prevents water from overtopping these levees. The height gap differs slightly between the walls located north and south of the bridge, due either to differing design heights or differential settlement following construction. At the distressed I-wall section on the southeast corner of the bridge, LIDAR surveys and visual inspection indicated the gap at this location was approximately 1.7 meters (5.6 feet). Therefore, water rising in the canal would overtop the bridge abutment and begin to flood the surrounding community when the water level was 1.7 meters (5.6 feet) below the top of the I-wall. Figure 7.15 shows this considerable wall gap, as well as moderate scour at the southeast edge of the bridge abutment (Figure 7.15a). On the northeast corner of the bridge abutment near the north levee wall, LIDAR surveys indicate the gap at this location to be approximately 1.51 meters (5.0 feet). Figure 7.16 and 7.17 show this gap, as well as a scour trench at the base of the northeast abutment (Figure 7.17a).

Figure 7.15: Photograph of the southeast abutment of the London Avenue Canal bridge at Robert E. Lee Blvd (a), and LIDAR scan of the same location (b). New soil and rock apparently fills scour and sink hole erosion beneath the abutment. The relative height gap between the bridge abutment and the flood wall is 1.72 meters (5.6 feet).

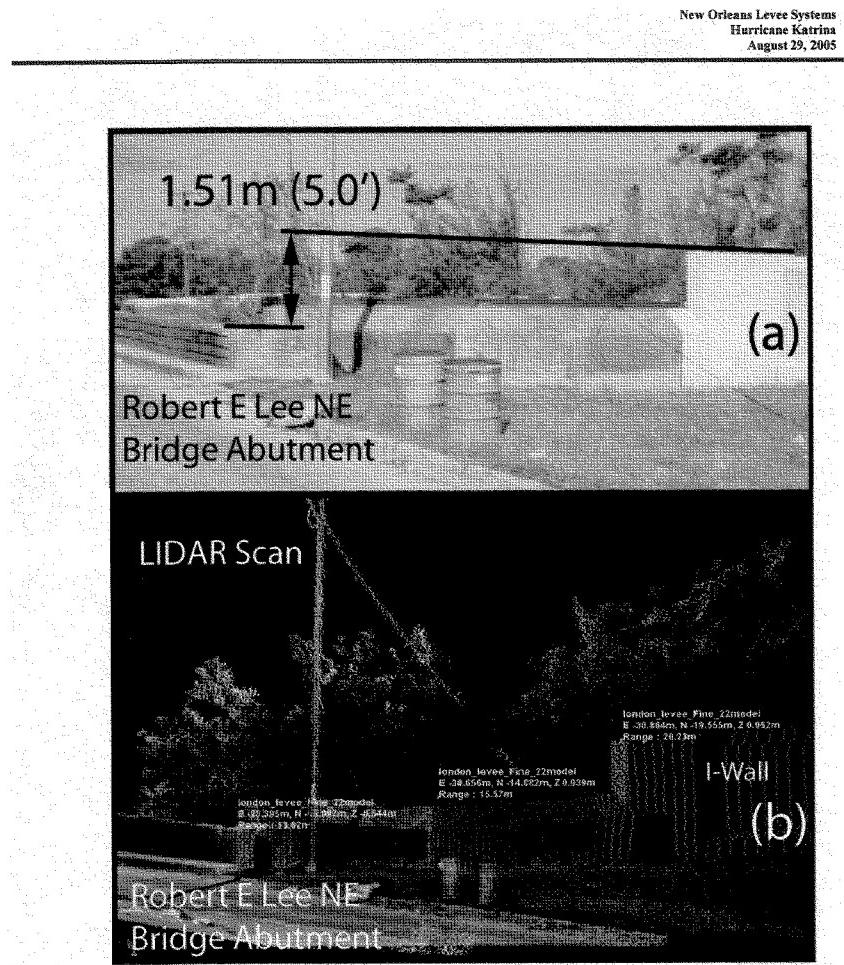
Figure 7.16: The northeast abutment of the London Avenue Canal bridge on Robert E. Lee Blvd. in photograph taken from the lower portion of the bridge approach-fill embankment (a), and corresponding LIDAR scan (b). The wall gap here is 1.51 meters (5.0 feet).

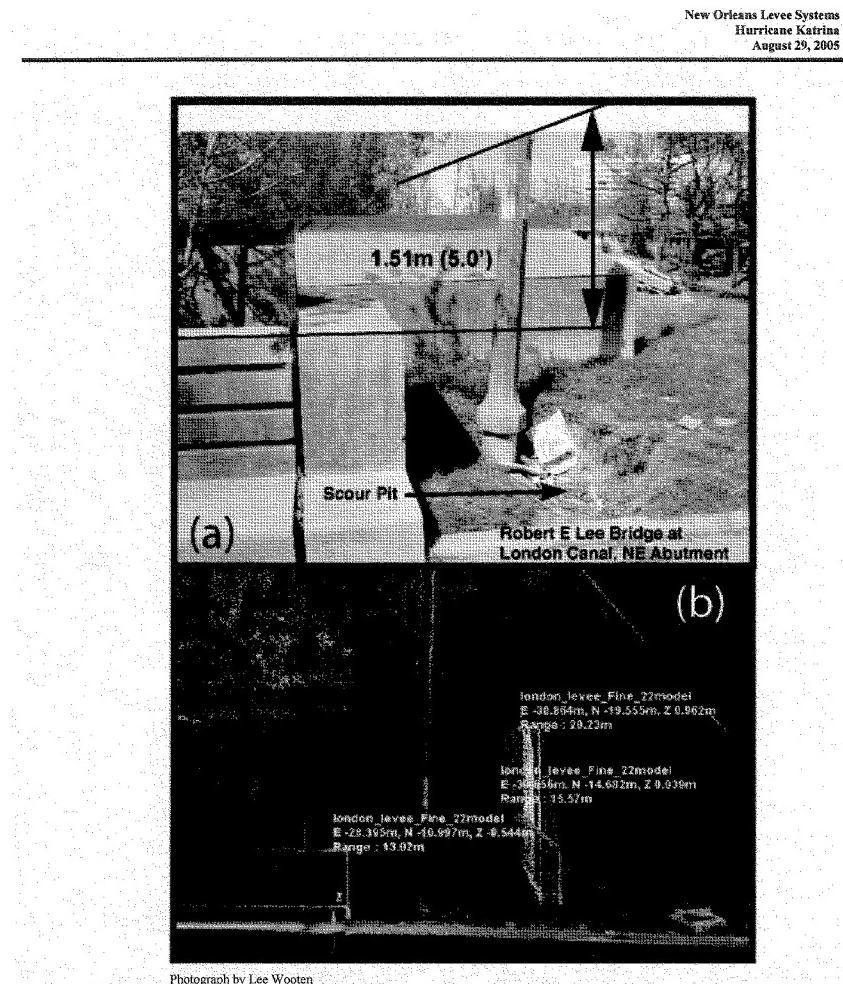
Figure 7.17: Photograph taken directly south and adjacent to the northeast abutment of the Robert E. Lee Bridge (a), and corresponding LIDAR scan of the same location (b). A scour trench is clearly visible beneath the abutment. The wall gap here is 1.51 meters (5.0 feet).

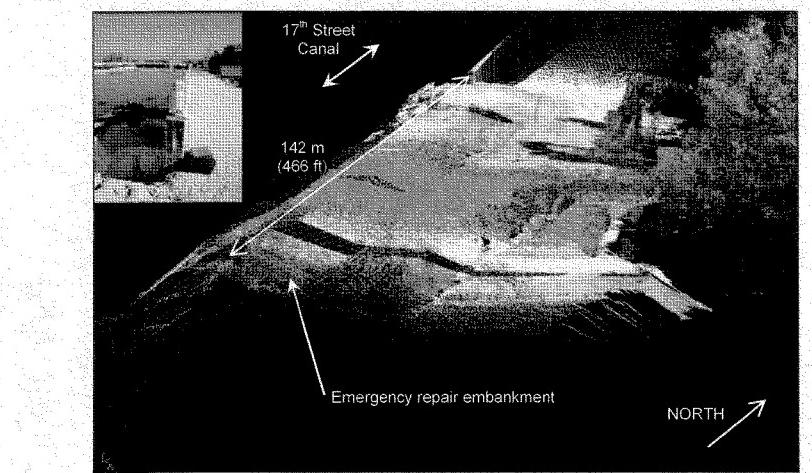
Figure 7.19. An oblique close-in image of the as built replacement levee at the 17th Street Canal breach from the south. The remaining I-wall is visible on either side of the earthen embankment.

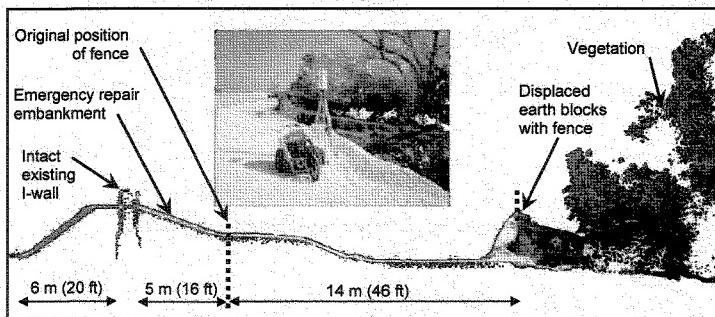
displacement of several earth blocks that moved away from the levee break during failure. While forensic work on the original positions of the earth blocks is still ongoing, the LIDAR data shows that blocks translated approximately 14 meters (46 feet) as measured from the existing alignment of the cyclone fence line to its new position within the displaced blocks. From the perspective shown in Figure 7.20, it can also be seen that the width of the 17th St. Canal has been reduced about 6 meters (20 feet) by the placement of the earthen embankment.

Figure 7.20 Cross-section of the 17th Street Canal breach looking northward. Measurement of the lateral translation of the landside soil levee from its original position is approximately 14 meters (46 ft). The I-wall in this image is offset (out of the page) from the slide block.

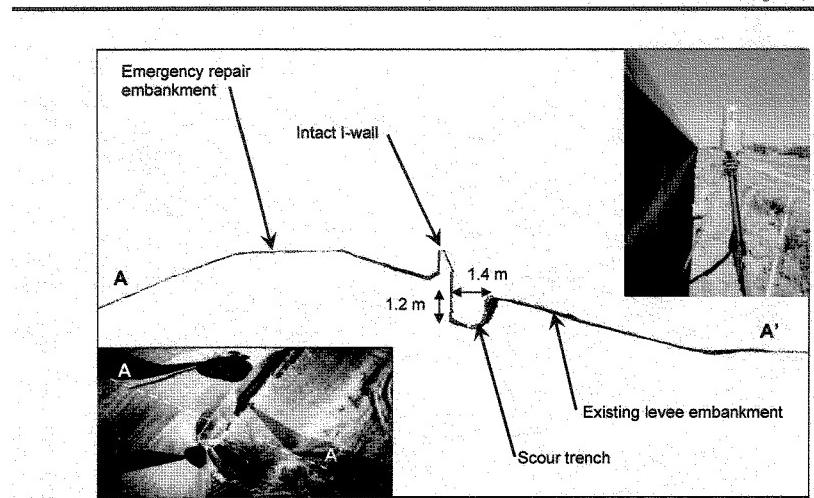
Figure 7.21: Measurement of scour trench dimensions at the IHNC – South site.
